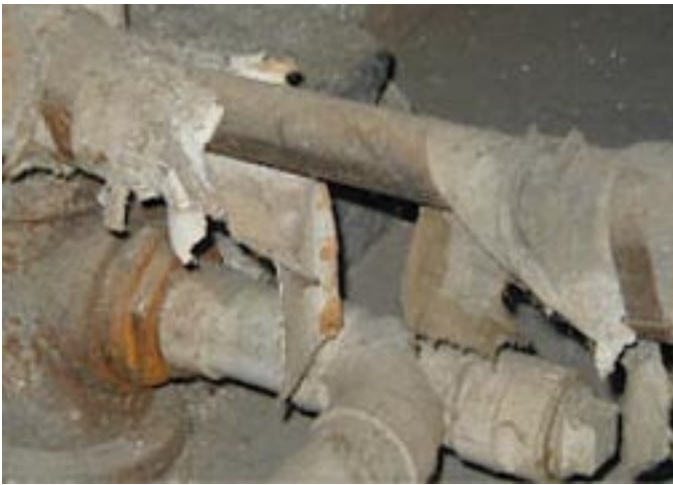
Damaged Suspect Asbestos Material.

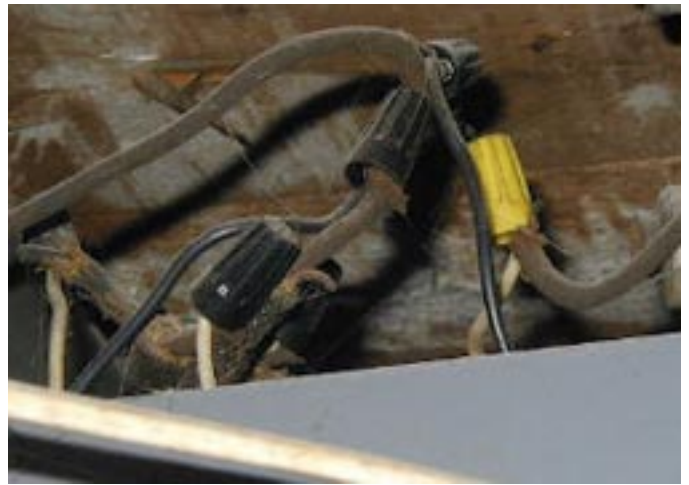
Old Knob And Tube Wiring.

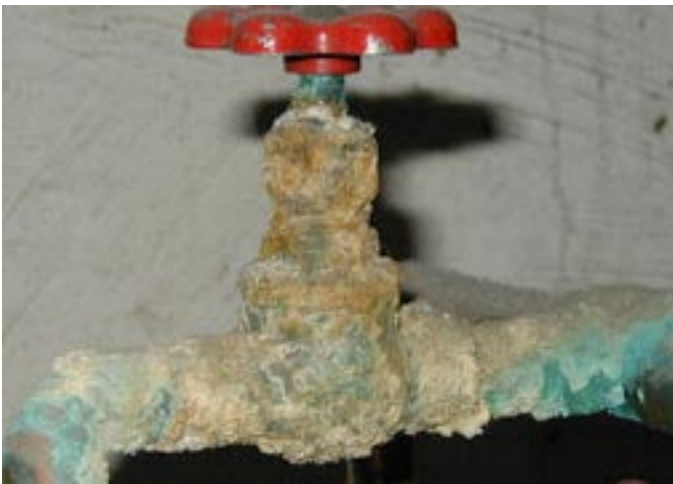
Severely Corroded Water Shut Off Valve.

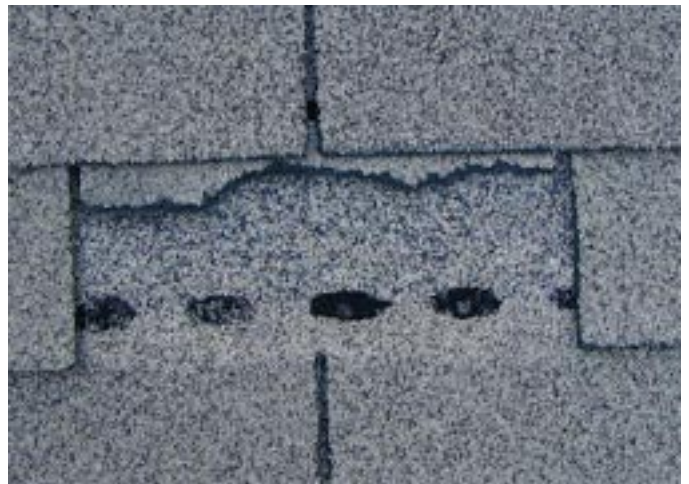
Torn / Damaged Roof Shingle.

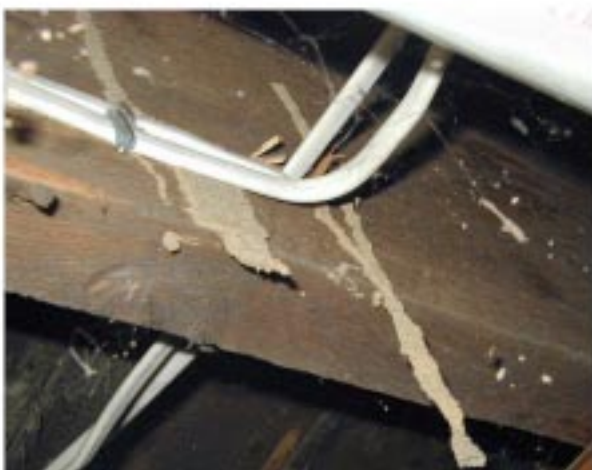
Termite Shelter Tubes And Termite Damage To Floor Joist.

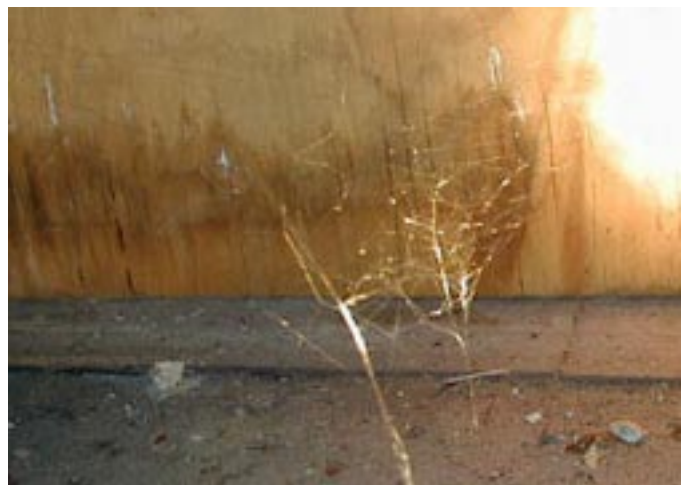
Evidence Of Past Water Presence In Basement.
